LEAD EROSION IN PERMANENT PACEMAKER: A CUMBERSOME COMPLICATION

J Ayub Med Coll Abbottabad 2014;26(2):174-7

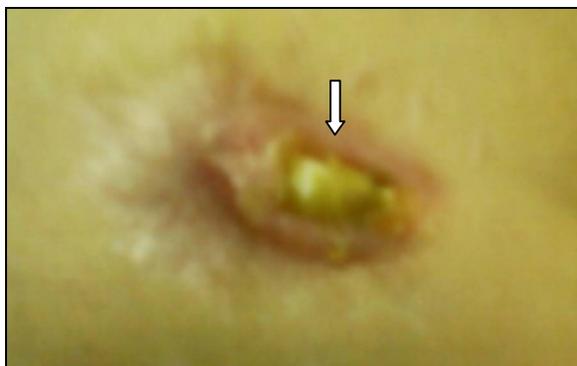
Figure-1: Lead erosion; lead sleeve is visible at the pacemaker implantation site (arrow)

Next day patient was taken to operating room and wound was opened under aseptic techniques. As first line strategy lead was embedded properly in two layers, first layer was with absorbable suture 1/0 Vicryl. Skin edges were refreshed and wound was closed using non-absorbable 4/0 proline with horizontal techniques. Because of granulation tissue deep dissection was not done and at this stage and muscular embedding was not done. All these cases were discussed with plastic surgeon as well. As per their advice mere burying in two layers was deemed good enough to yield good results.

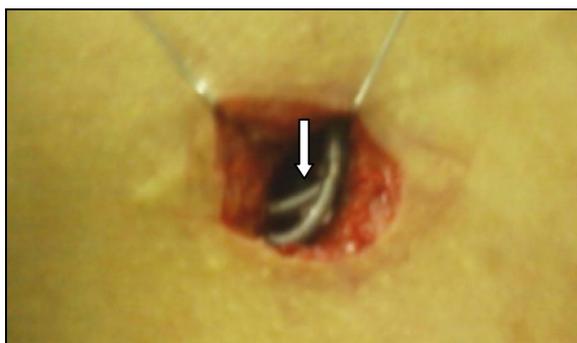
Figure-2: Leads exposed through skin incision. Leads are lying in the incision line; it was the possible cause of lead erosion

The rate of complication is independent of the nature of the device; that is, single chamber verses dual chamber.^{13,14} However the large assembly of the dual chamber and double leads does matter. If the large size of the leads are not handled properly it will easily come into the incision line and can erode the skin.

Moreover the success rate of re-implantation again depends on the skill of the operator and the suture he selects. If the assembly is properly embedded in the muscles and covered in three layers; and the wires are kept away from the incision line the healing rate is great.^{17,18} Suture selection is also important. The one that is less irritant will yield good results like proline¹⁹ instead of silk. Both these sutures are non-absorbable
